# Memorandum

**To:** Arthur Londensky, Borough of South River

**From:** Felipe S. Contreras, P.E., C.M.E., C.F.M., Kleinfelder

**Re:** **Water Quality Complaints Investigations**

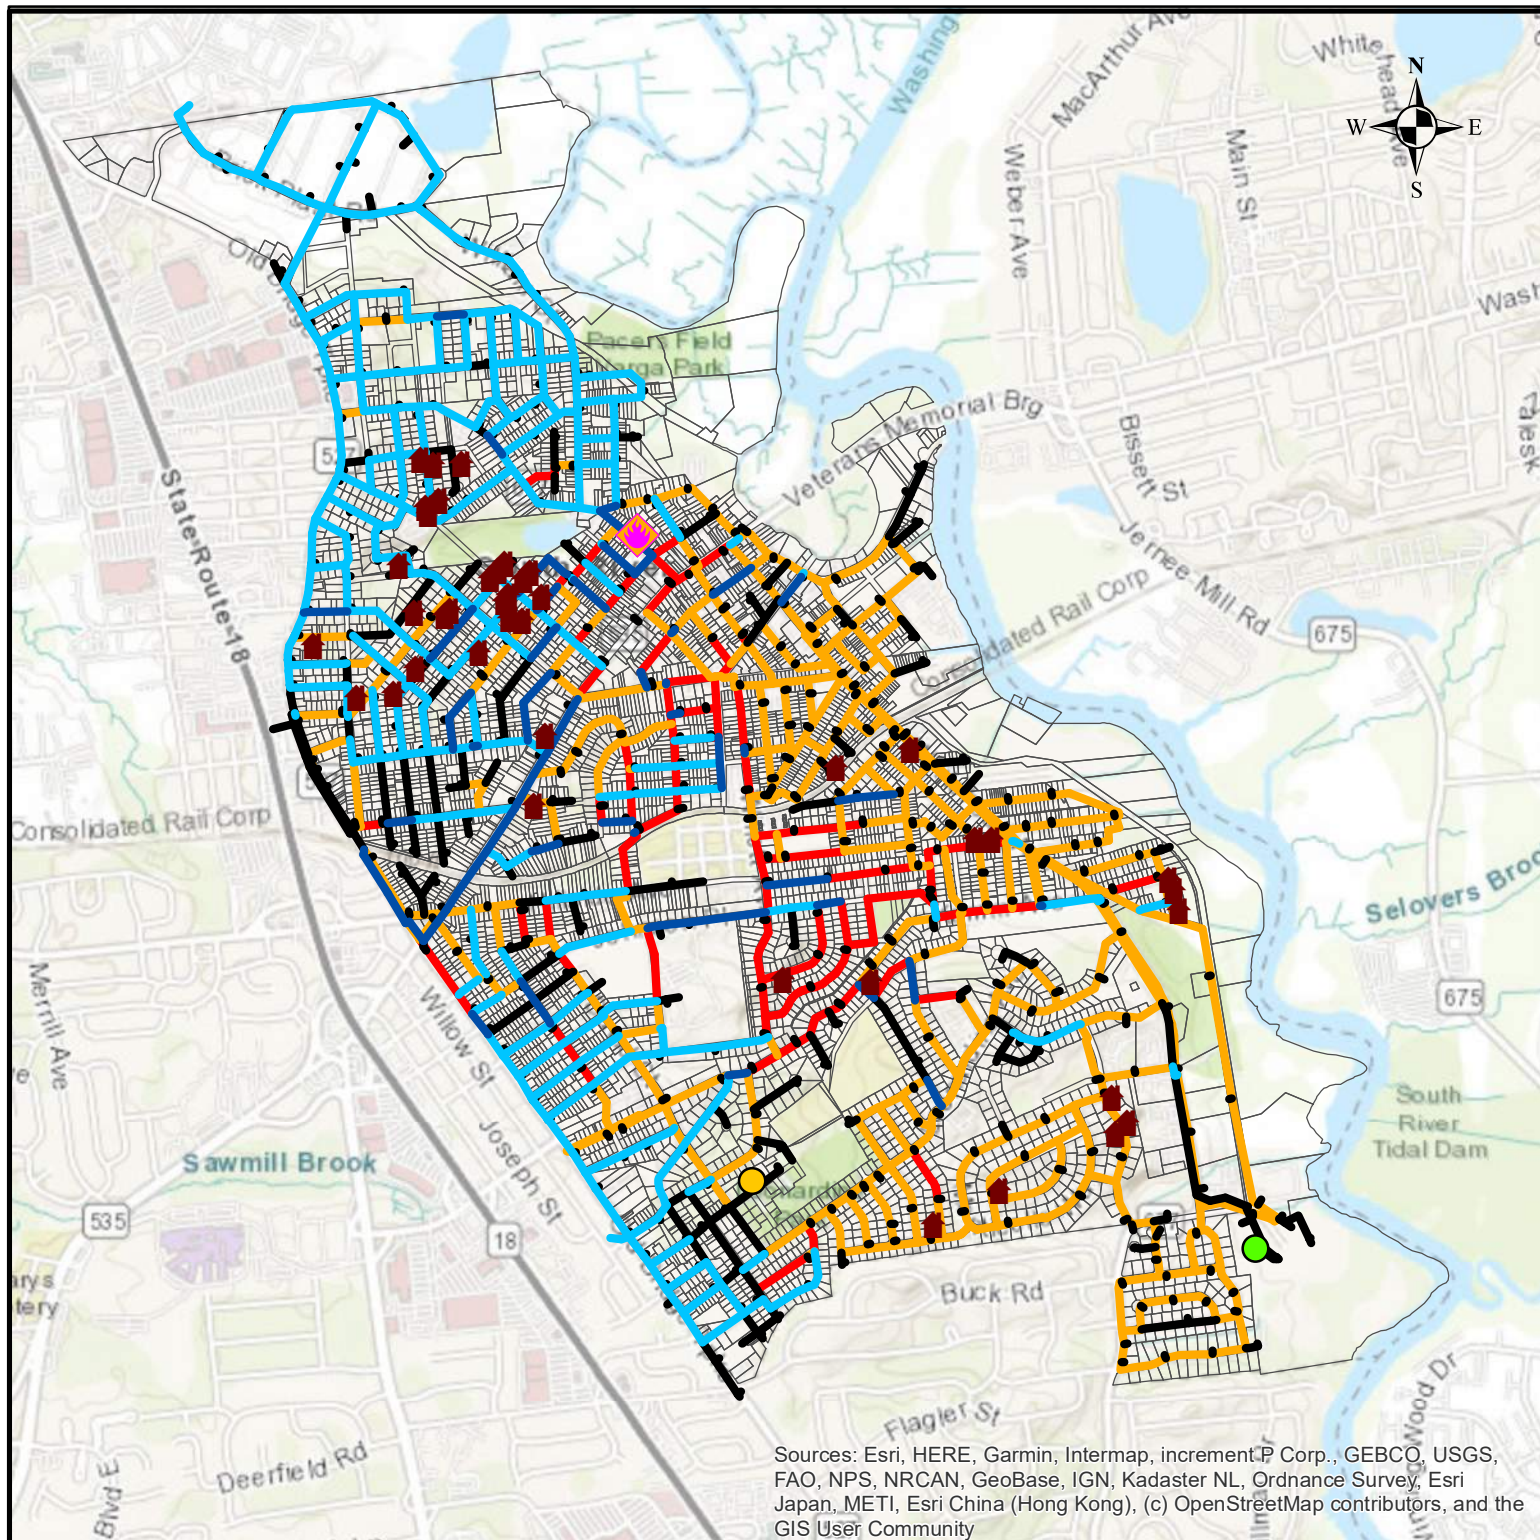
**FIGURE A -  
FIRE IMPACT ON FLOW  
DISTRIBUTION IN SOUTH RIVER**

As shown in Figure A, a large majority of the pipe segments in the town saw a change in flow direction, and nearly all the segments saw an increase in flow and velocity as a result of the fire that occurred. This means the fire demand had a significant impact on nearly the entire distribution system, creating a disturbance to the normal conditions in the system. Such disturbances can result in the dislodging of sediment from the walls of the pipe and the movement of old water to different areas in the distribution system.

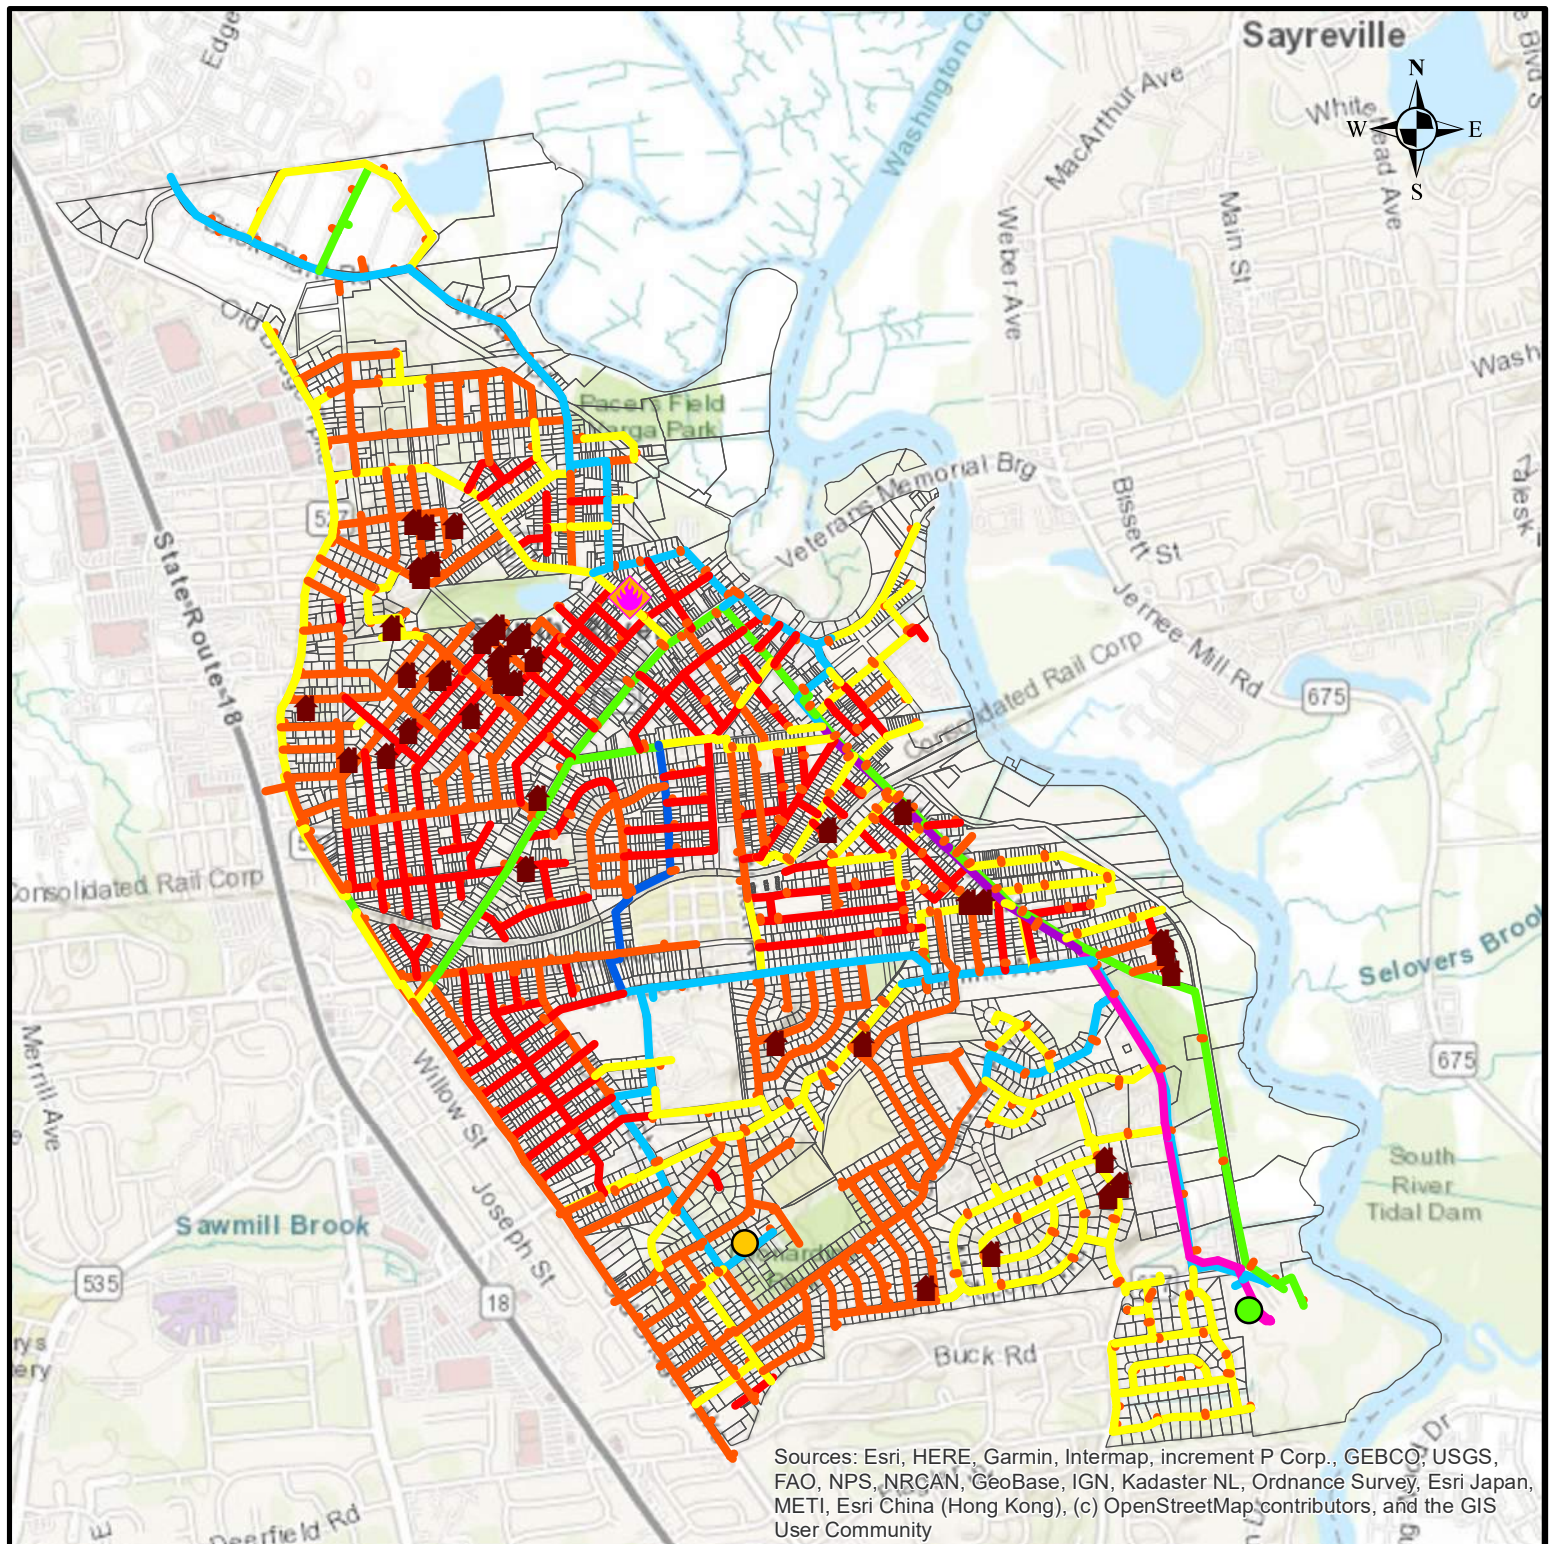
## FIGURE B - WATER DISTRIBUTION SYSTEM PIPE SIZE DIAMETERS

Figure B provides the diameters of the pipes in the distribution system. The red and orange pipes are 4-inch- and 6-inch-diameter pipes, respectively, and these segments make up 57% of the linear footage of water main in the distribution system (including 6-inch-diameter hydrant laterals). Under normal average day demand conditions, typical lower velocities are observed in the 4-inch and 6-inch segments, consistent with normal consumption demands, and the water in the system moves in a consistent pattern. When a high demand like the fire flow occurs, the normal flow patterns and directions are disrupted, and velocities are increased. This results in an abrupt shift of older water from one area of the system to another and a disruption to the sediment and film build-up on the interior of the pipes, which would not occur under normal demand conditions. This disturbance is even worse in smaller diameter pipes, such as 4-inch and 6-inch diameters, because for the same volume of flow, the velocity will be greater in a smaller diameter pipe compared to a larger diameter pipe.

Based on the findings of the modeled scenarios and knowledge of the conditions of the distribution system, it is recommended that the 4-inch- and 6-inch-diameter water mains be replaced with 8-inch-diameter water mains, contingent on further confirmation with fire flow criteria. In accordance with N.J.A.C. 5:21-5.3, water mains shall be a minimum of 8 inches, except under limited specific conditions. Increasing the size of the small diameter water mains will result in lower velocities in these pipes during events like high demand fire flow scenarios, and therefore less disturbance to the distribution system.

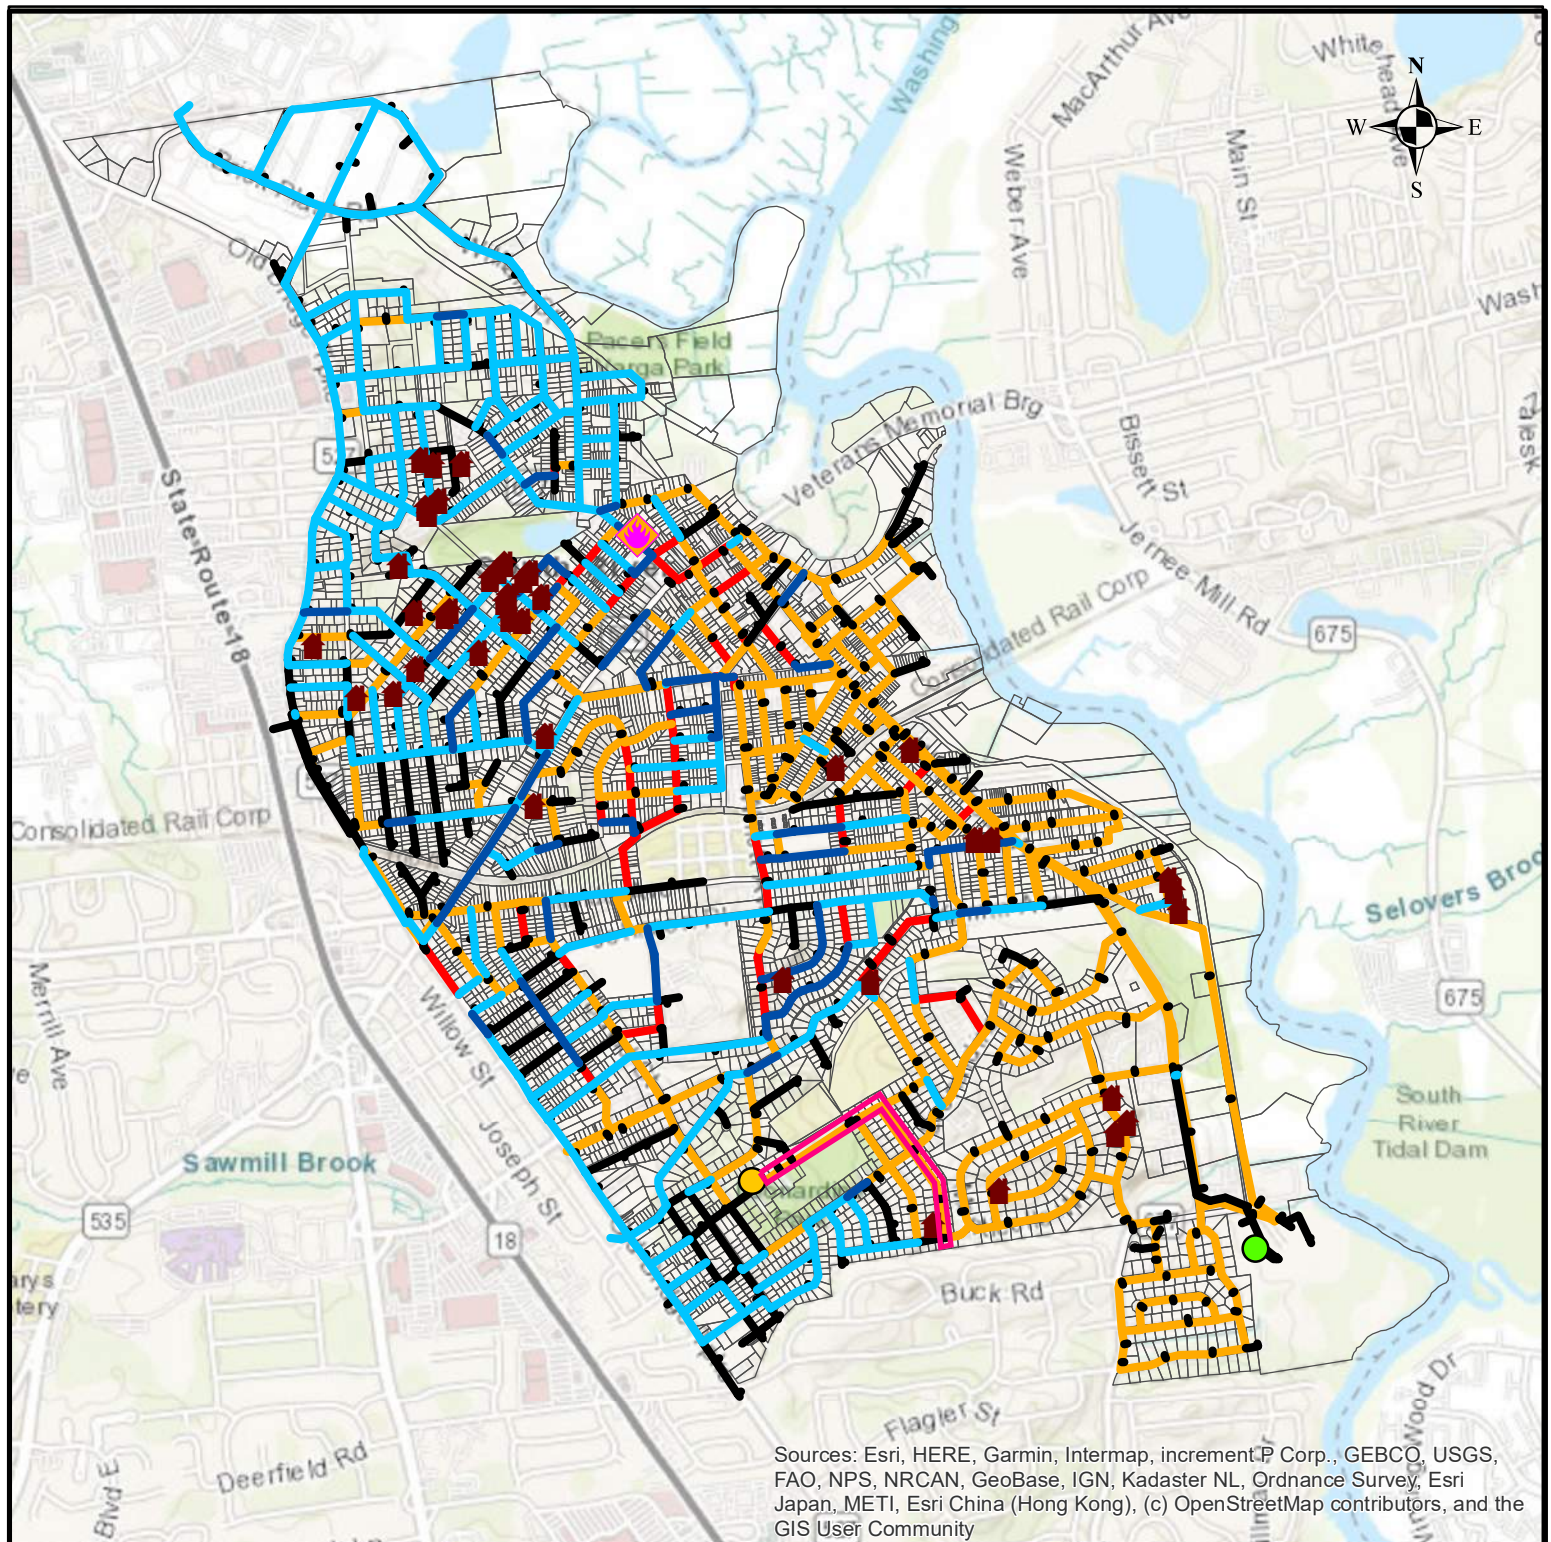
**FIGURE C -  
FIRE IMPACT ON FLOW  
DISTRIBUTION IN SOUTH RIVER  
WITH EXTENSION 1**

Street, crossing through Dailey's Pond Recreational Area. The third proposed extension is located on Hillside Avenue and connects the dead end main on Hillside Avenue to the perpendicular water main on Willet Avenue. The hydraulic model was run with the addition of these water main extensions for the same fire event, and the same flow and velocity analysis was conducted. Figures C, D, and E show these results. As seen in the figures, the water main extensions allow for greater movement of water through the system with results in less areas of significant increases in flow and velocity, with a change in direction (red pipes and orange pipes), and an increase in pipes that do not see a significant change due to the fire (black pipes).

In addition, it is recommended that additional looping connections at strategic locations in the distribution system be added to reduce water stagnation and increase firefighting capacity, by increasing the number of pathways that the water can travel throughout the system from one area to another. A minimum of three (3) new interconnections or water main extensions of 8-inch diameter main will be made between larger diameter distribution mains to currently isolated areas of the system to improve reliability of distribution throughout the system and reduce water travel time. The first proposed extension is located by the Appleby Tank and will connect the dead end of Appleby Ave to the 8-inch main on Colin Drive, crossing through Leonardine Park. The second proposed extension is located between the dead end of Cleveland Avenue and water main on John
